UNITED STATES
NUCLEAR REGULATORY COMMISSION
OFFICE OF INSPECTION AND ENFORCEMENT
WASHINGTON, D.C. 20555

IE Bulletin No. 79-13
Revision 2

CRACKING IN FEEDWATER SYSTEM PIPING

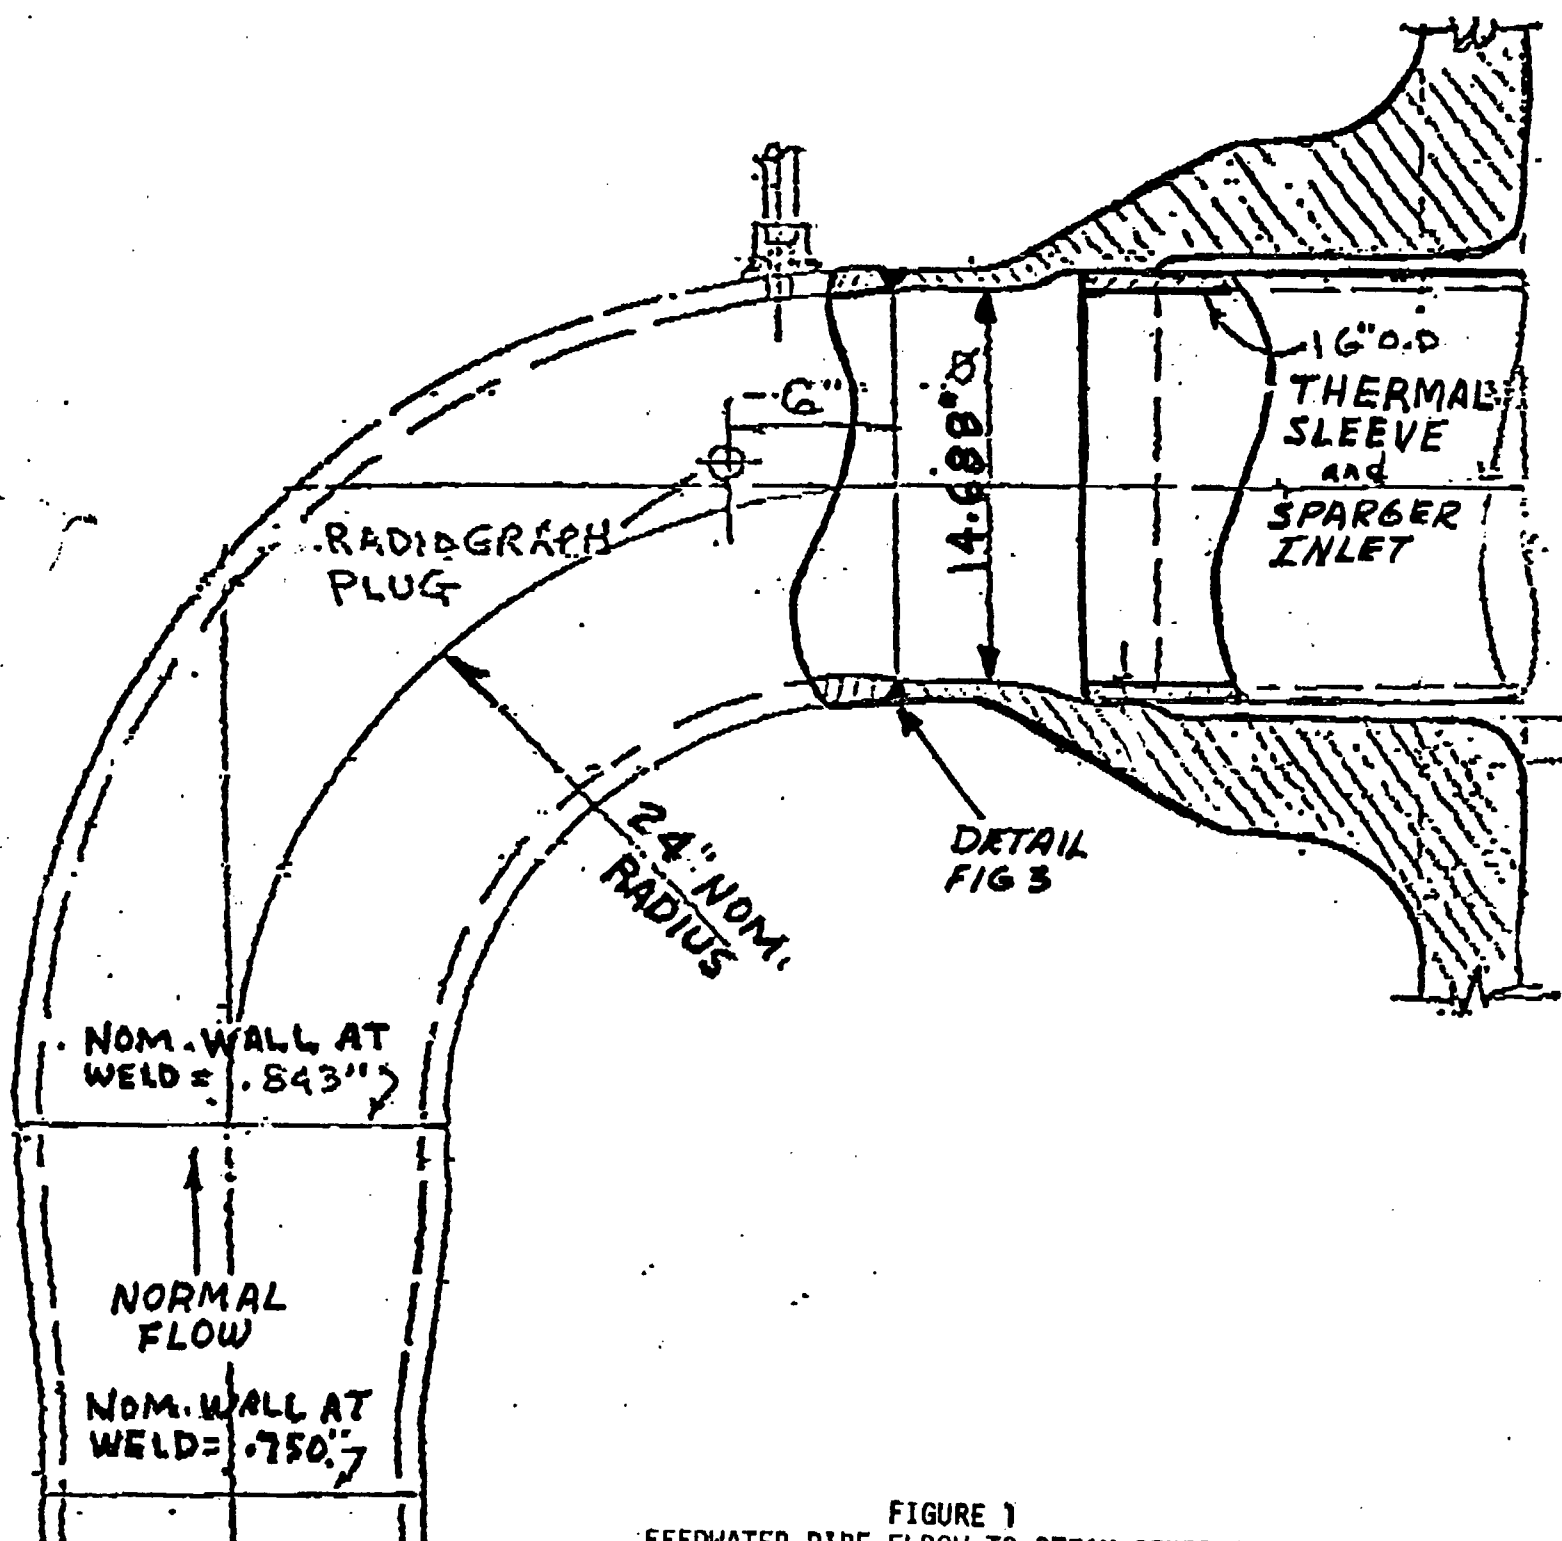
FIGURE 1
FEEDWATER PIPE ELBOW TO STEAM GENERATOR
NOZZLE INSTALLATION (DC COOK)

On May 20, 1979, Indiana and Michigan Power Company notified the NRC of cracking in two feedwater lines at their D. C. Cook Unit 2 facility. The cracking was discovered following a shutdown on May 19 to investigate leakage inside containment. Leaking circumferential cracks were identified in the 16-inch feedwater elbows adjacent to two steam generator nozzle elbow welds. Subsequent radiographic examination revealed crack indications in all eight steam generator feedwater lines at this location on both Units 1 and 2.

The feedwater nozzle-to-pipe configurations for D. C. Cook and for San Onofre are shown on the attached figures 1 and 2. A typical feedwater nozzle-to-pipe weld joint detail showing the principal crack locations for D. C. Cook and San Onofre are shown on the attached figure 3.

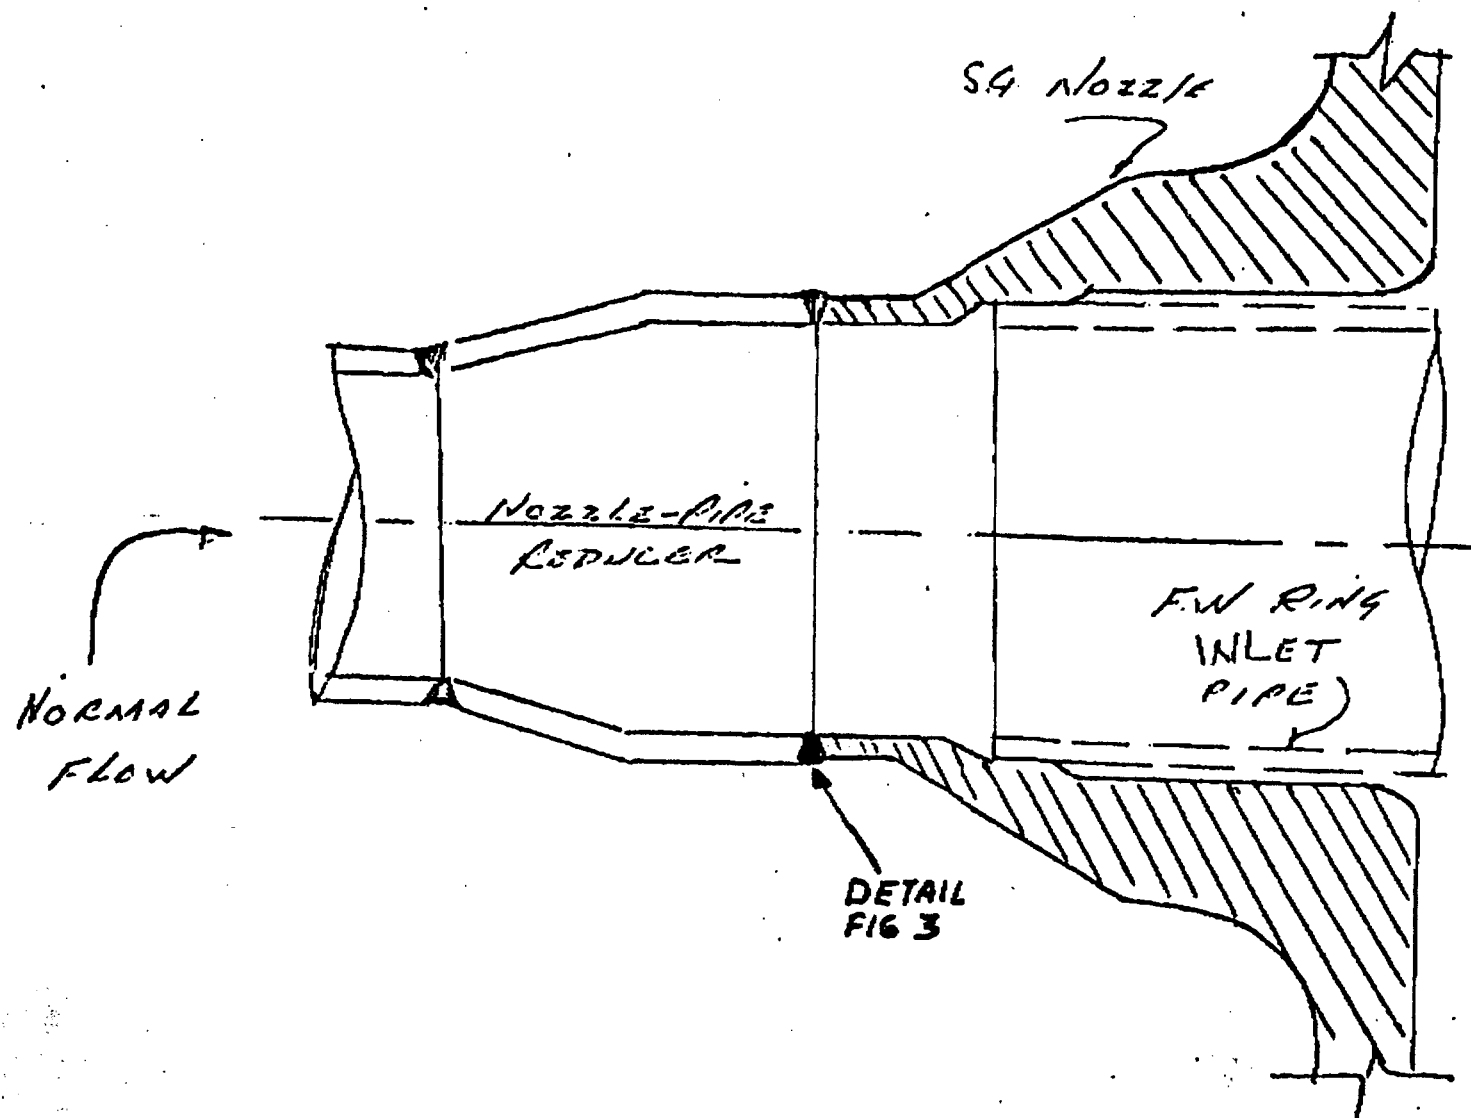
FIGURE 2
FEEDWATER PIPE REDUCER TO STEAM GENERATOR
NOZZLE INSTALLATION (SAN ONOFRE)

As a result of these actions, several other licensees with Westinghouse steam generators reported crack indications. Southern California Edison reported on June 5, 1979, that radiographic examination revealed indications of cracking in feedwater nozzle-to-pipe welds on two of three steam generators of San Onofre Unit 1. On June 15, 1979, Carolina Power and Light reported that radiography showed crack indications in similar locations at their H. B. Robinson Unit 2. Duquesne Power and Light confirmed on June 18, 1979, that radiography has shown cracking in their Beaver Valley Unit 1 feedwater piping-to-vessel nozzle weld. Public Service Electric and Gas Company reported on June 20, 1979 that Salem Unit 1 also has crack indications. Wisconsin Public Service company decided on June 20, 1979 to cut out a feedwater nozzle-to-pipe weld which contained questionable indication, for metallurgical examination. As of June 22, 1979 and since May 25, 1979 seven other PWR facilities have inspected the feedwater nozzle-to-pipe welds without finding cracking indications.

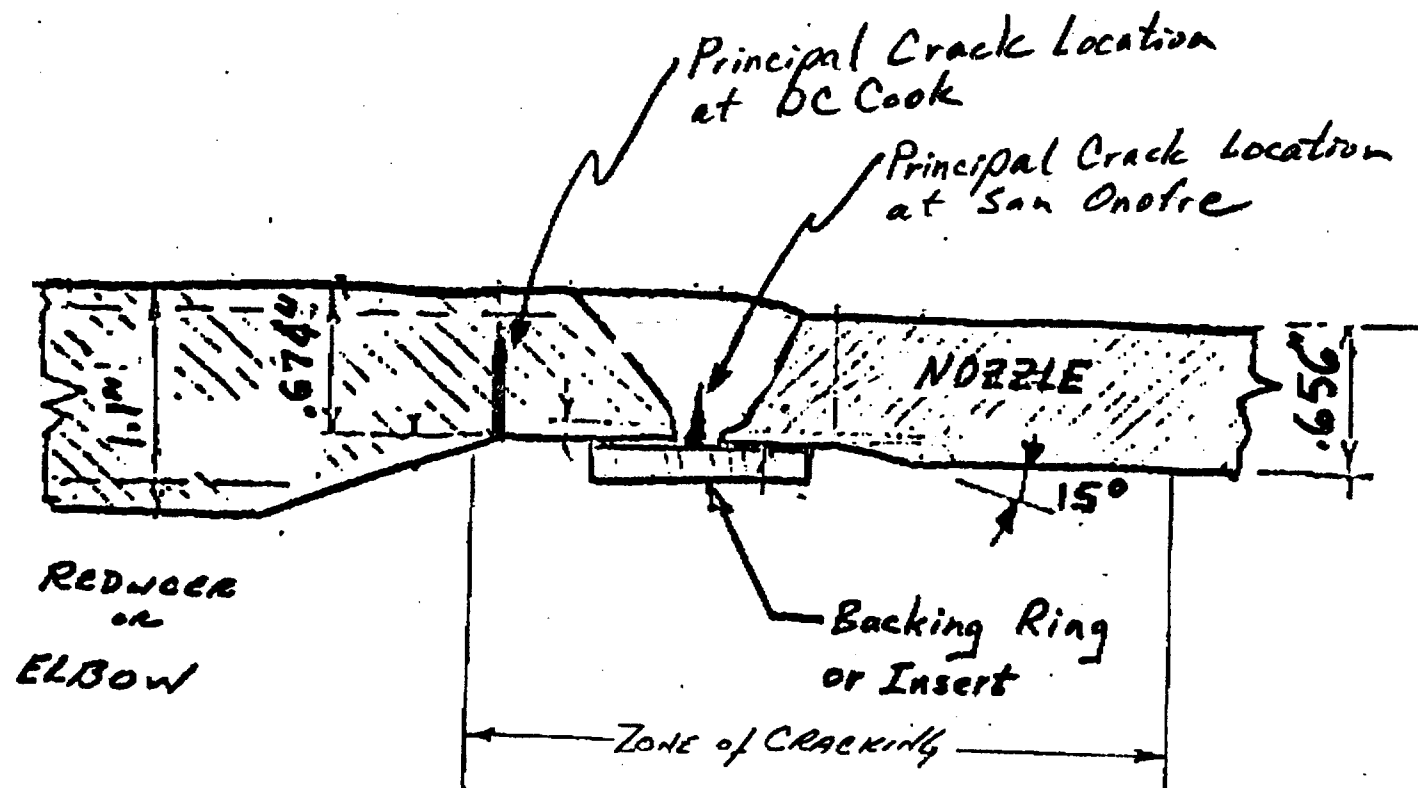
FIGURE 3
TYPICAL FEEDWATER PIPE TO NOZZLE
WELD JOINT DETAIL
(W , CE)

An extensive metallurgical investigation has been conducted by Westinghouse on a substantial number of cracked weldments removed from the above plants. Results of the metallurgical analysis lead to the conclusion that a corrosion fatigue phenomenon is the probable failure mechanism, except for the San Onofre piping which has been characterized as stress assisted corrosion.

- a. Perform radiographic examination, supplemented by ultrasonic examination as necessary to evaluate indications, of all feedwater nozzle-to-pipe welds and of adjacent pipe and nozzle areas (a distance equal to at least two wall thicknesses). Evaluation shall be in accordance with ASME Section III, Subsection NC, Article NC-5000. Radiography shall be performed to the 2T penetrameter sensitivity level, in lieu of Table NC-5111-1, with systems void of water.

- b. In the event cracking is identified during examination of the nozzle-to-pipe weld, all feedwater line welds up to the first piping support or snubber outboard of the nozzle shall be volumetrically examined in accordance with 1.a above. All unacceptable code discontinuities shall be subject to repair unless justification for continued operation is provided.
